Site Visit Report #005
PROJECT: Lakewood High School

DATE: March 28, 2016
Project: 2014-05

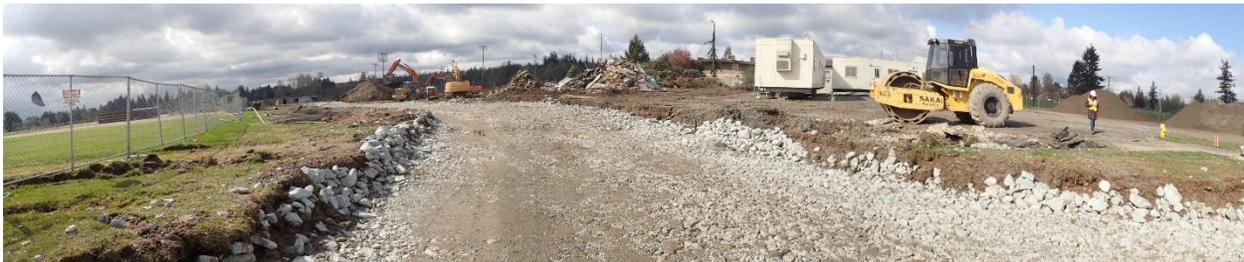
3. East-west portion of the future temporary bus route, quarry-spall surfaced, appears firm and unyielding. All-terrain dump truck, fully loaded with ground asphalt, used to proof-roll the area.

Panorama – view SW & W of haul road / bus route quarry spall surface and ACA trailers. Gravel stockpiles can be seen at right side of view.

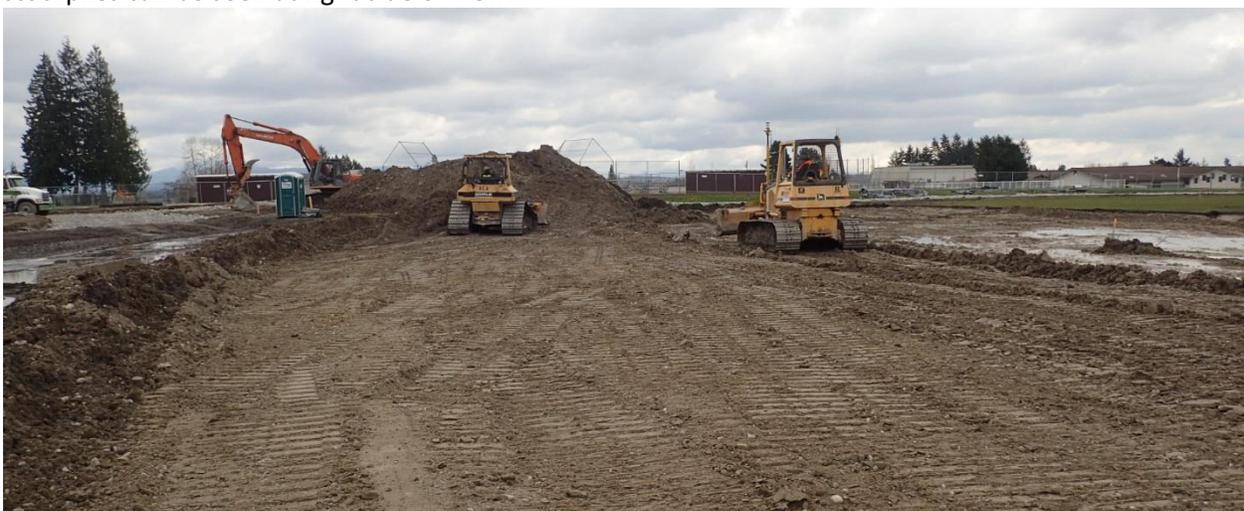
5. Dozer working to establish building subgrade is leaving distinct track marks on surface, suggesting that the area now exposed is rather firm.
6. Water which had accumulated on flat subgrade, where ground-up asphalt had been removed, is being pumped from a temporary shallow depression NE of the Condenser enclosure. Runoff from elementary school fields appears to drain to the NE corner of those fields, bringing water to the utility crossing noted in #3. ACA suggested installation of an interceptor (French drain) along the west side of the fields, connecting to the next catch basin south.

View East of North Classroom Wing subgrade. Mound of soil will be exported.

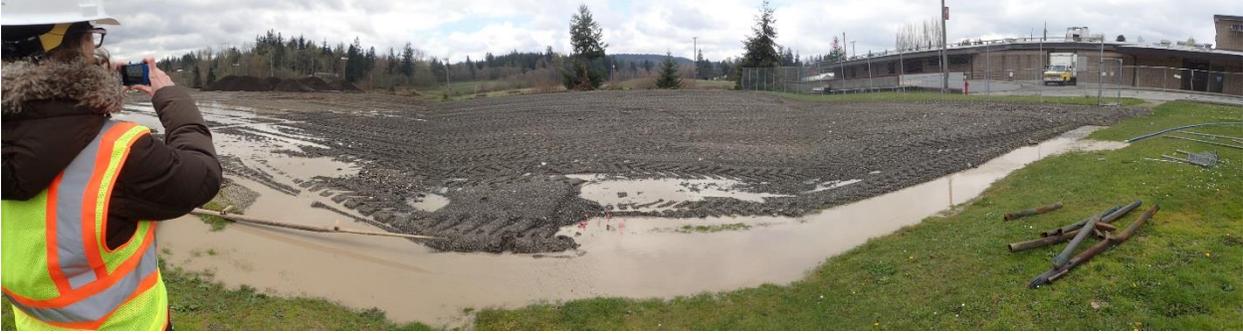
View west across former tennis courts. Note discharge of water (item #8) from hose at right side.

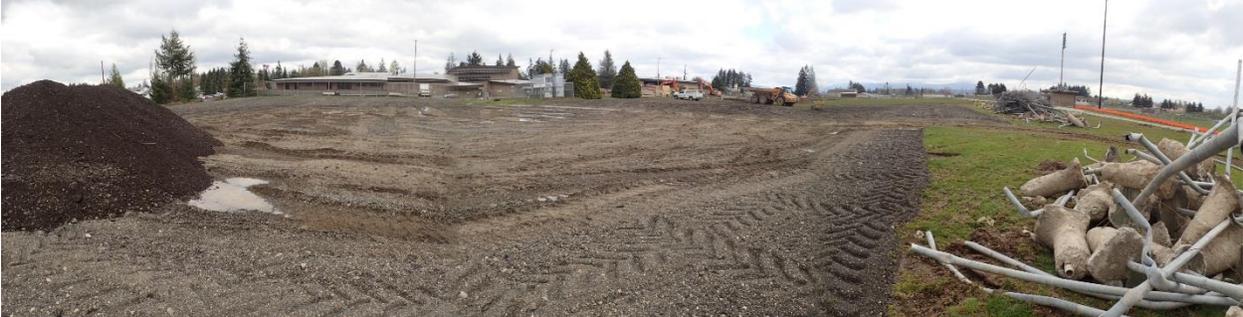
4. ACA is removing the ground-up asphalt paving from the south portion of the former bus loop, and moving with all-terrain dump truck to stockpile location near the south end of the Auxiliary Gym.

Panorama from near south side of Auxiliary Gym. Stockpile of asphalt grindings at left.

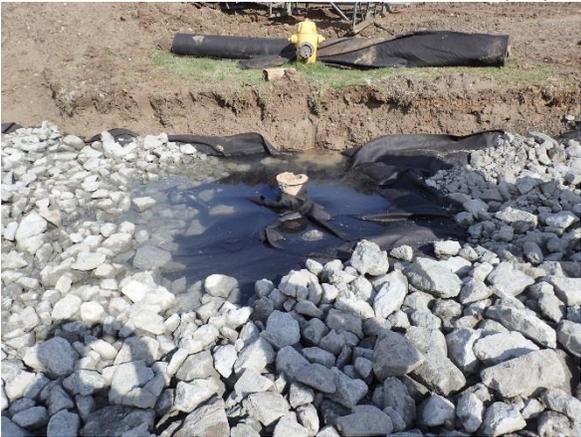
Standing water at valve for hydrant

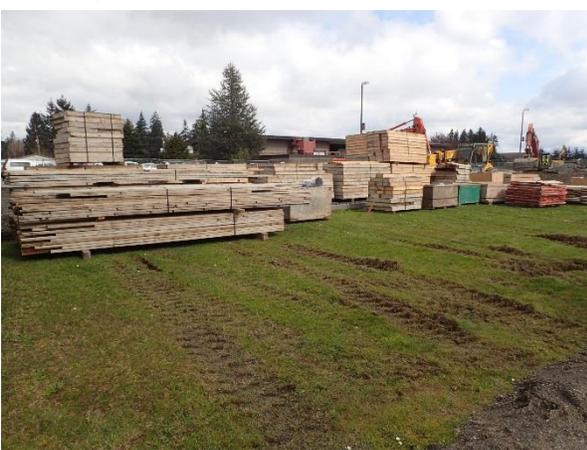
7. Some formwork materials have been stockpiled on-site.

Stockpiled formwork material

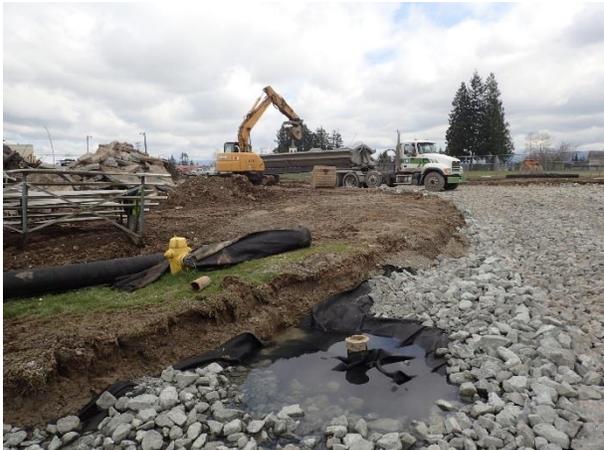
Greenhouse slab export
